# Cisco Chain of Lakes 2012 Invasive Species Assessment

# Cisco Chain Riparian Owners Association

## The Sigurd Olson Environmental Institute at Northland College

**November 4, 2012**

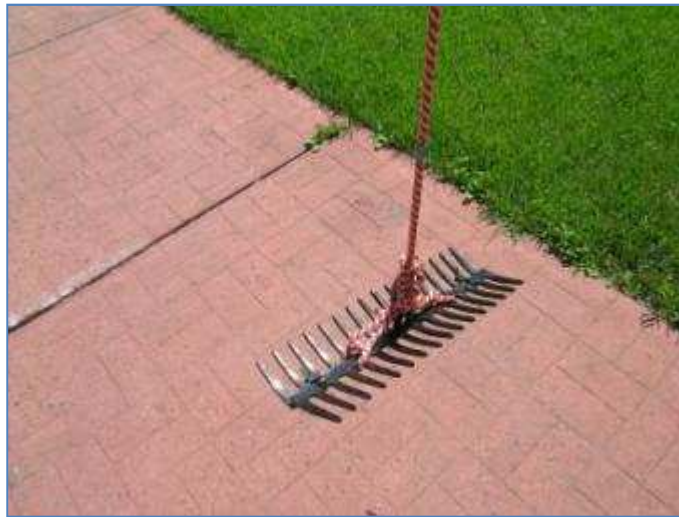
**Figure 2** – Double-headed rake

At each sample point, plant communities were sampled using a double-sided rake sampling device (Figure 2). Following the WDNR procedure, the rake is dropped to the bottom, dragged for approximately one-foot and pulled to the surface. Once in the boat, the different species are identified and the relative density of the individual species and total plant density are recorded as rake fullness (Figure 3). Species composition and relative density data are recorded on the WDNR survey form and voucher species are kept for each species at each lake. In addition to species data, water depth and sample site location are measured and recorded at each point using a handheld sonar and GPS units. In lakes with large numbers of points in deep water (e.g., Thousand Island Lake), sampling is concentrated in shallower (depth of less than 20 feet) littoral areas.

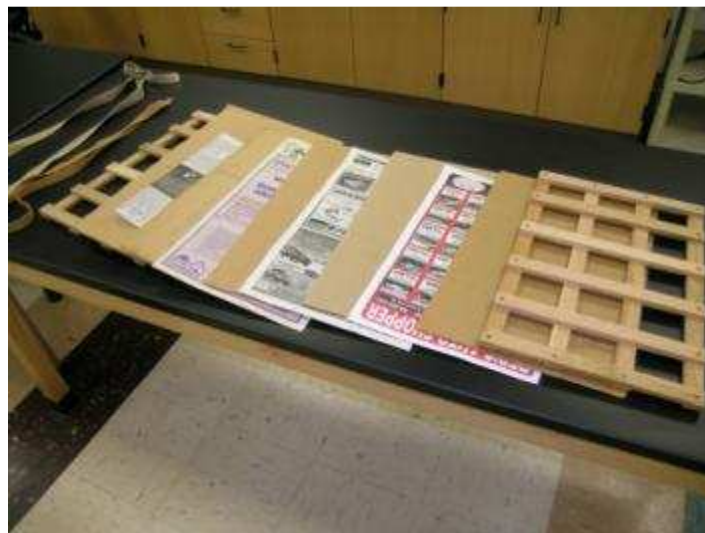
**Figure 6** – Plant pressing and drying system.

Voucher specimens were retained for all species in all lakes and identified to species using: “Michigan Flora” Part I, by Edward G. Voss (1972); as well as the “Manual of Aquatic Plants” by Norman C. Fassett (1940). Voucher specimens were then pressed, dried and archived at the Sigurd Olson Environmental Institute (Figure 6).
