## East Bay Lake

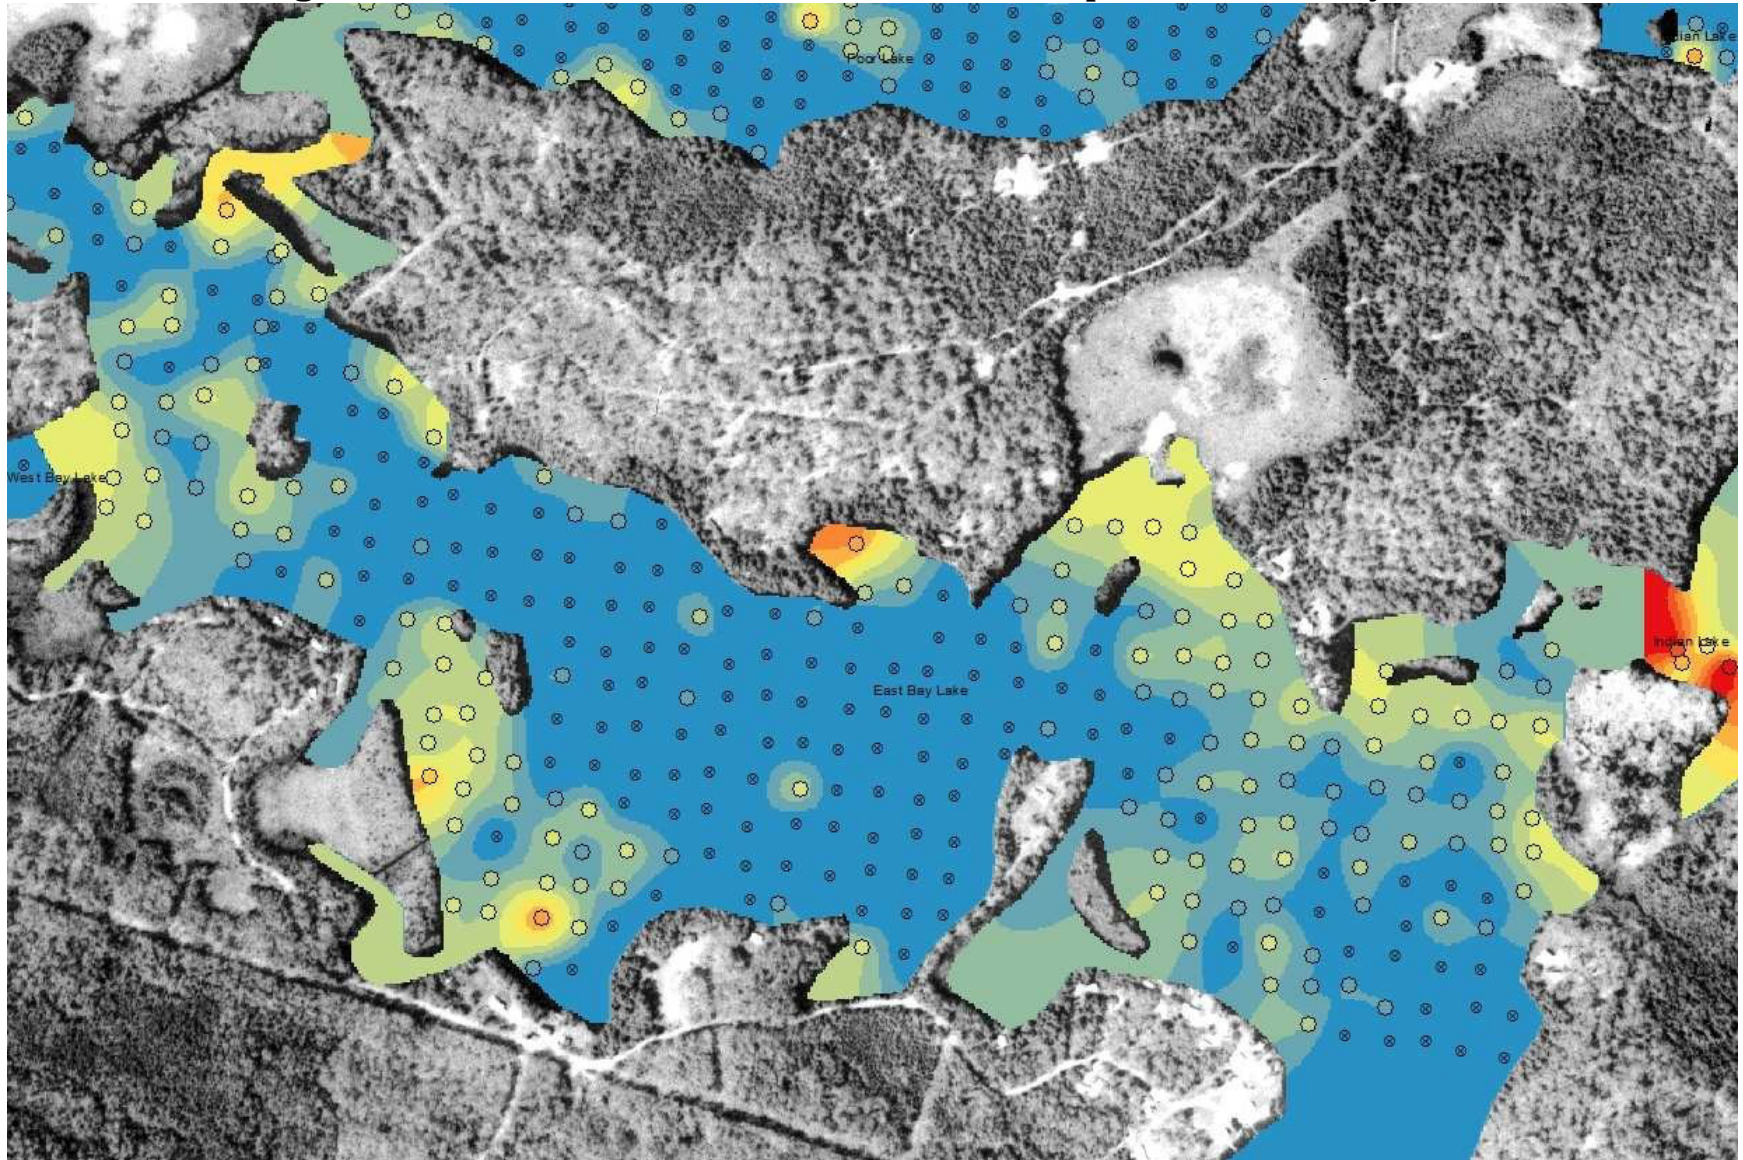
**Figure 12 - Distribution of Native and Invasive Species in East Bay Lake**

Fifteen native species were detected in East Bay Lake (Table 6). Aquatic plants were detected at most of the points within the shallow waters of East Bay Lake, with the areas of greatest density and species richness occurring along the northeastern and southwestern shorelines (Figure 12). Floristic Quality Index values for East Bay Lake are consistent with regional averages.
